## CASE STUDY: K-Sure® Belt Support & K-Containment® Seal

| Kinder Australia Products: | <b>K-Sure® Belt Support System &amp; K-Containment® Seal</b> |
| Site Location: | Ohau Quarry, Levin, New Zealand |
| Location on Conveyor: | Conveyor Transfer Point |

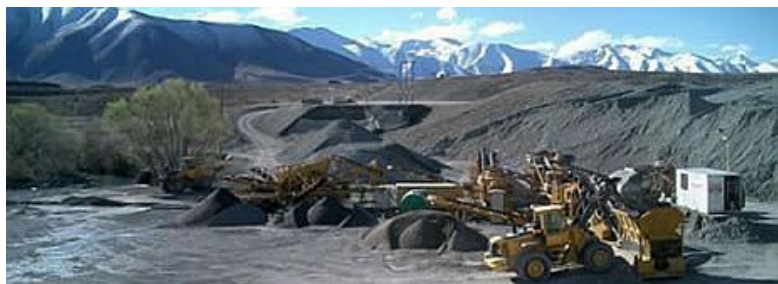
Ohau Quarry had issues with face rock getting past the skirt, resulting in significant damage to the belt. Typically the conveyor belt would be changed out every 3 months due to the re-occurrence of the **impact damage**, caused by the large, sharp face rock lumps striking the belt. Entrapment damage was also being experienced, created by friction between the rock material on the belt, the belt surface and the bottom of the skirt board when the **belt sags**.
