## Case Study – K-Cleanguard Belt Pre-Cleaner

| <b>Kinder Australia Product:</b> | <b><u>K-Cleanguard Belt Pre-Cleaner</u></b> |
| <b>Location:</b> | Calama, Chile |

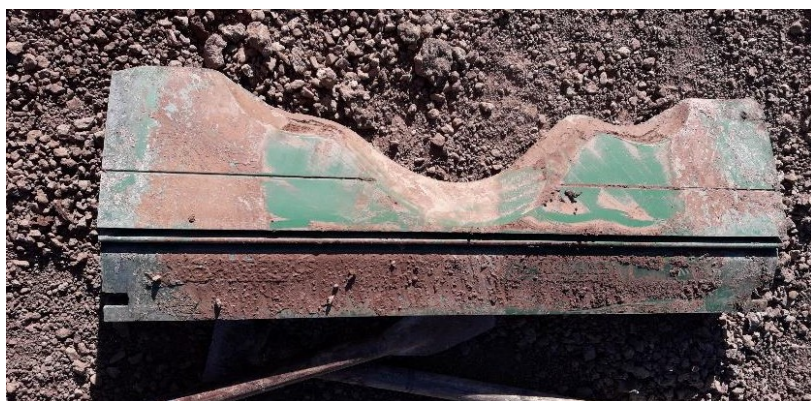
The belt cleaner's blade premature wear was taking place because the blade was actually "cutting" through the main ore flow of the belt. This happened because of an increased moisture content in the transported ore, which turned it into a highly cohesive paste that wouldn't fly off the belt's surface at the discharge pulley.

Instead, it stuck to the belt surface, and went along with it as the belt turned with the pulley, ending up being projected almost in a reversing direction.

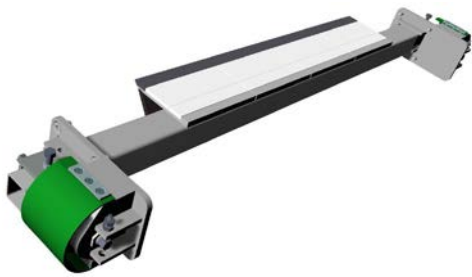
#### K-Cleanguard Belt Pre-Cleaner

After analysing the problem we introduced the client to **K-Cleanguard Belt Pre-Cleaner**, a belt cleaner specifically designed to engage the main ore flow and separate it from the belt's surface. Thus, the **K-Cleanguard Belt Pre-Cleaner** restores (to the extent possible) the original design flow trajectory and, most importantly, allows the remaining belt cleaners to operate normally, restoring the whole conveyor system to a normal working condition.

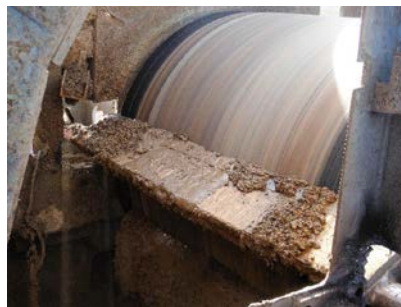
Pre-Cleaner – No load

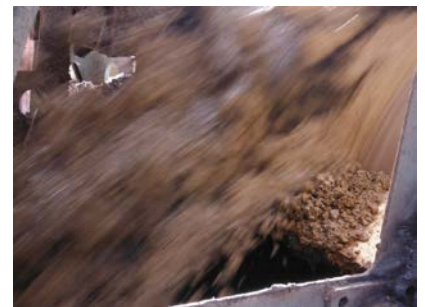
Pre-Cleaner – Under operation

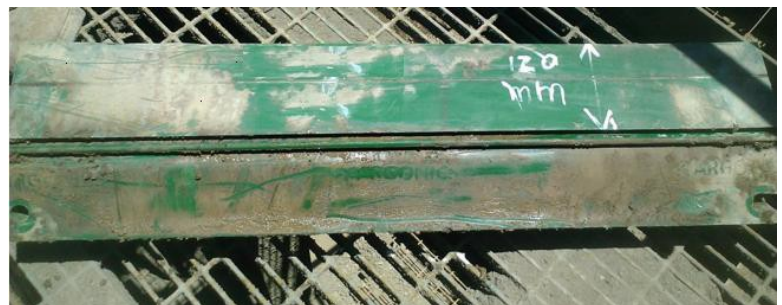
After installing the **K-Cleanguard Belt Pre-Cleaner** the client saw immediate results: The wear life of the primary belt cleaner's blade is now over 7 times longer, extending the maintenance frequency from every two days to every two weeks. Effectively reducing the demand of man-hours to less than a seventh. The **K-Cleanguard Belt Pre-Cleaner** blade lasts 15 days as well.
