## Case Study – K-Redi-Liner® Polyurethane

| <b>Kinder Australia Product:</b> | <b><u>K-Redi-Liner® Polyurethane G83</u></b> |
| <b>Location:</b> | Victoria |

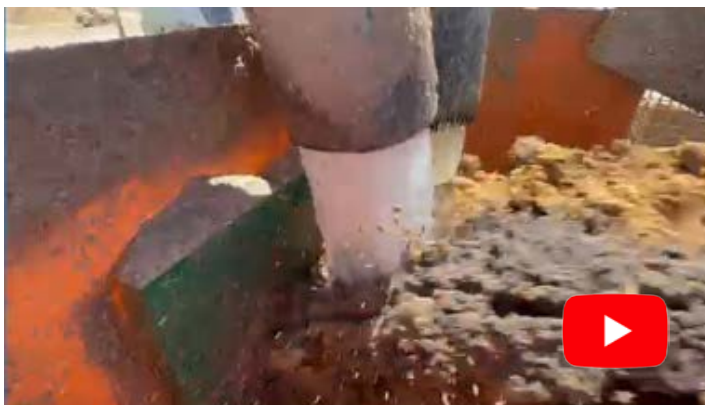
**After Photo / Video:**  
K-Redi-Liner® Polyurethane installed at the head discharge chute.

Installation was simple and efficient, utilising a single-bolting technique and a 2 x 2 panel configuration in high-wear areas. The K-Redi-Liner® Polyurethane G83 was also lined throughout the lower chute for complete wear protection. K-Redi-Liner® Polyurethane panels are lightweight and manual-handling friendly, making installation even more seamless while minimising downtime.

**Since the installation in July 2024, the customer has experienced zero replacements and zero maintenance requirements.** After 8 months of operation, K-Redi-Liner® Polyurethane G83 has shown minimal wear, significantly extended the wear life of the head chute and eliminated costly downtime.
